*U.S. Air Force Rapid Airfield Damage Repair Modernization Program*

## **Refinement of Foam Backfill Technology for Expedient Airfield Damage Repair**

Phase II: Development of Prototype Foam Dispensing Equipment and Improved  
Tactics, Techniques and Procedures

December 2017

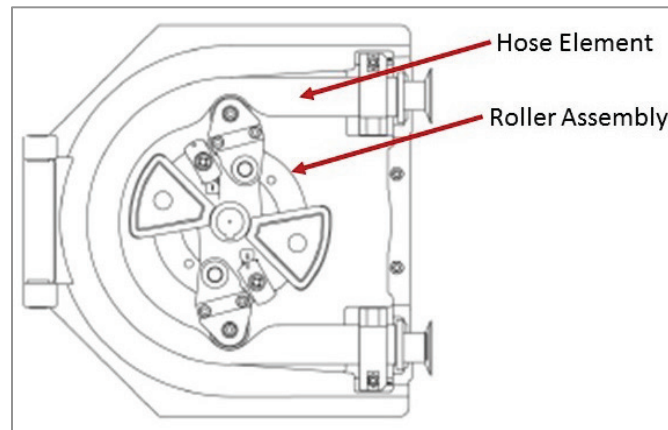
Figure 2.1. Representative hose pump head.

the fluid is completely separate from the moving parts of the pump head. If fluid components begin crystallizing in the transfer hoses and clogging the system, the entire fluid path may be replaced without exposure to the foam components.

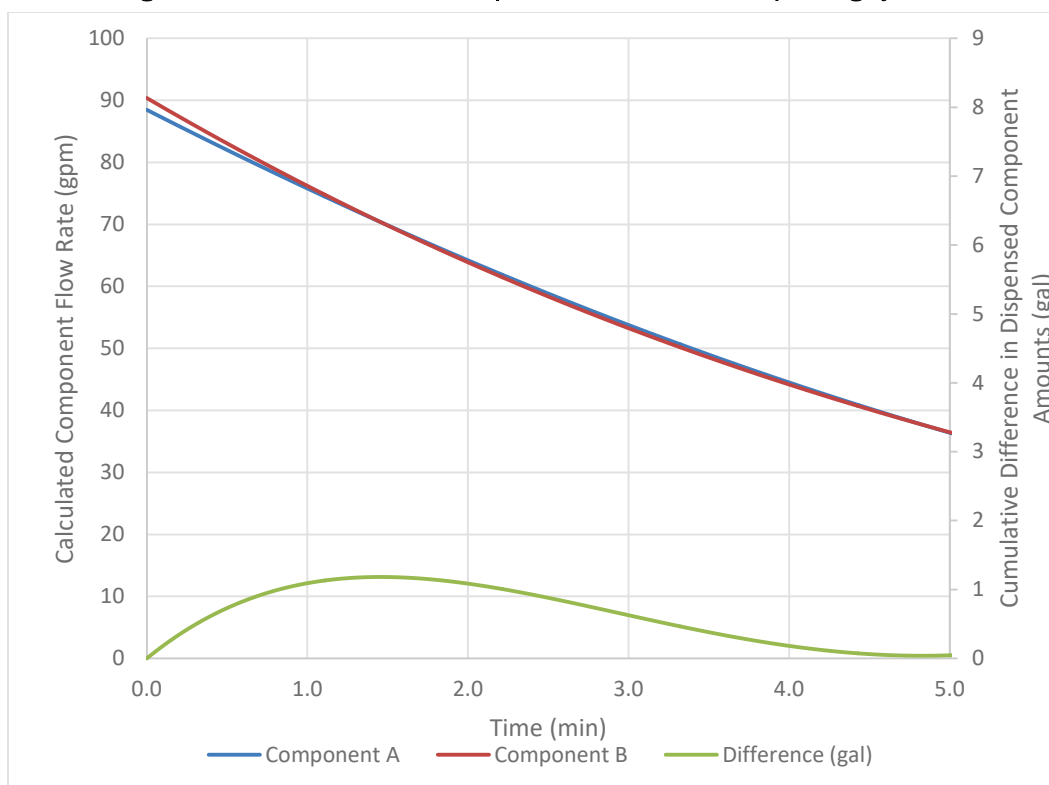
Figure 2.2. Predicted flow from a pressure driven foam dispensing system.

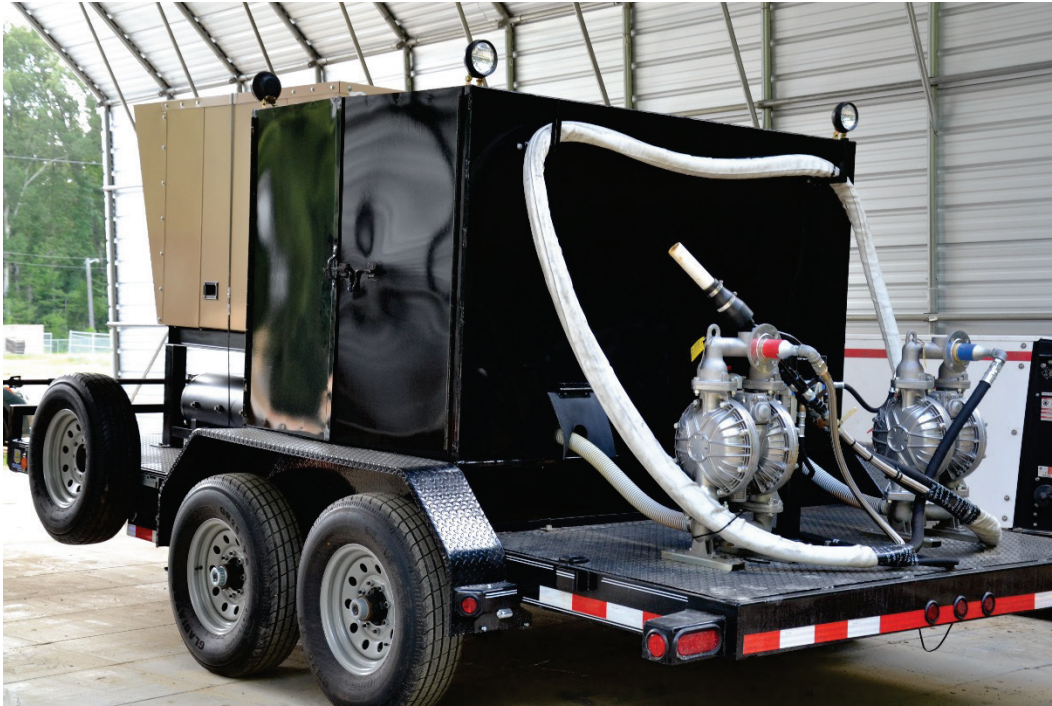
Figure 2.3. HMI prototype.

A commercial prototype was specially designed and constructed for this project by HMI of Manitowoc, WI. The HMI prototype is a trailer-mounted unit that relies on diaphragm pumps to deliver foam components through a mixing nozzle into the repair crater. Rather than a static mixing element, the design of this system uses higher delivery velocity through an impinging jet head to accomplish mixing of the two components.

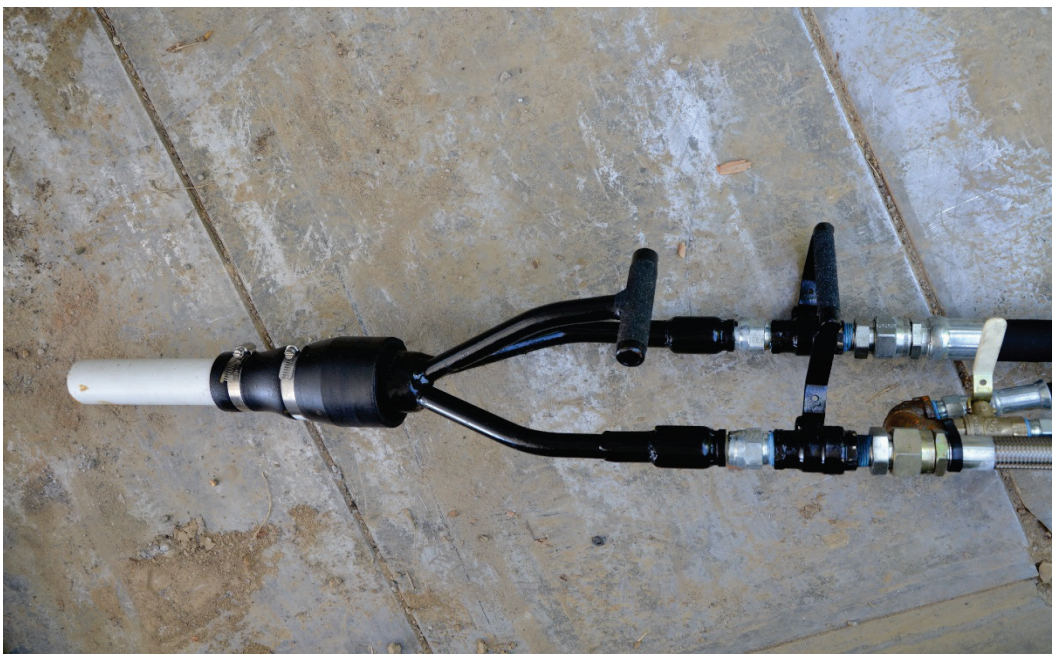
Figure 2.4. HMI prototype mixing nozzle with fluid flow and air controls.

The mixing nozzle and prototype dispensing controls are shown in Figure 2.4. The nozzle consists of two steel-pipe component lines directed to a single steel outlet head. This outlet is covered by a flexible coupling and a short section of 1.5-in. PVC pipe. During dispensing, the foam components exit the outlet head at high velocity and impinge within the PVC pipe, creating a well-mixed foam material. The nozzle is connected to two 3/4-in. stainless steel ball valves that are connected by a welded steel handle. The fluid lines are opened by pulling this handle towards the operator. Pump operation is begun by opening a 1/2-in. ball valve at the mixing nozzle to allow air flow from the compressor to the diaphragm pump motors. Since the diaphragm pumps are capable of generating high outlet pressures, it is important to always open the fluid lines at the mixing nozzle before opening the air valve to start the pumps. If this procedure is not followed, it is

possible that high pressure could burst a pump diaphragm or component hose. It is also possible that high pressure in the foam lines could cause operator injury upon opening the fluid lines. Because of these safety concerns, future designs of this type should include mechanical stops that prevent opening the air valve unless the fluid valves are open.

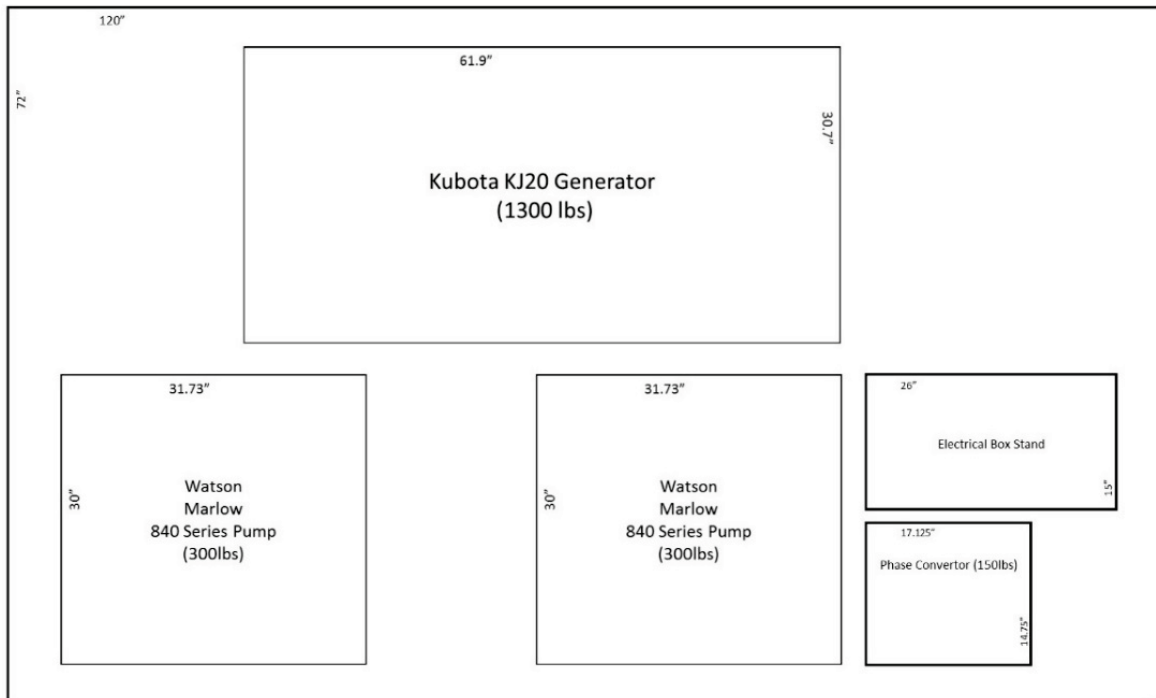
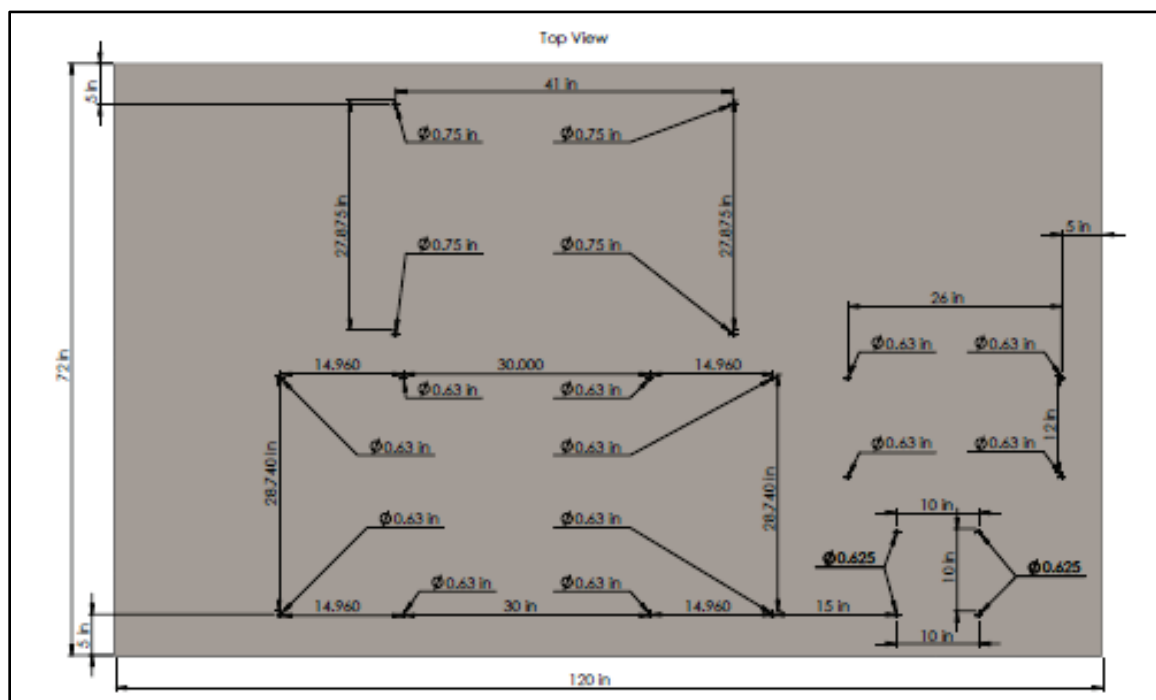
Figure 3.1. Skid layouts for CRADR1 prototype.

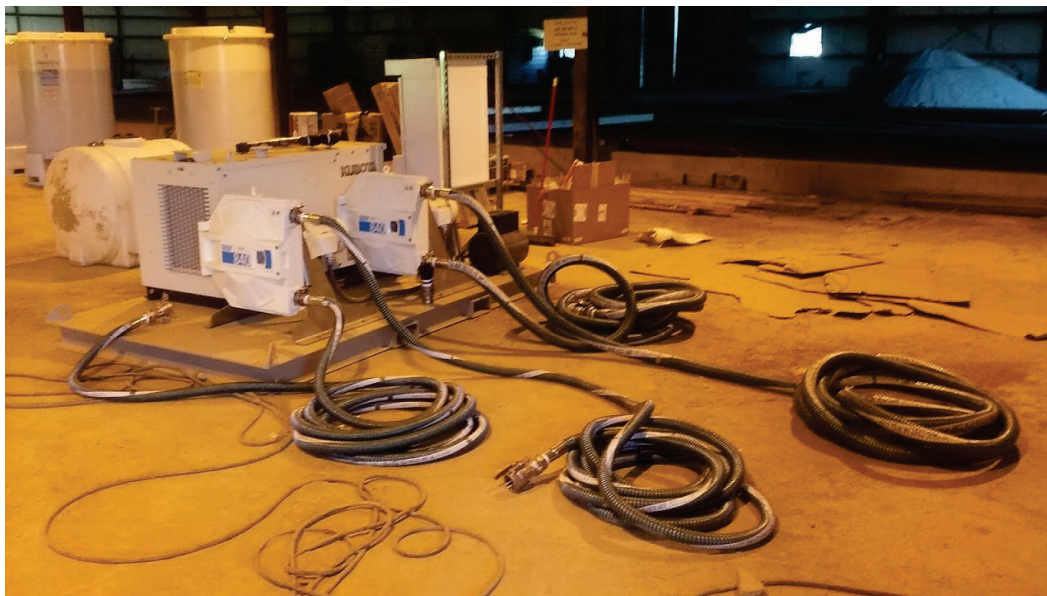
Figure 3.2. Assembled CRADR1 prototype.

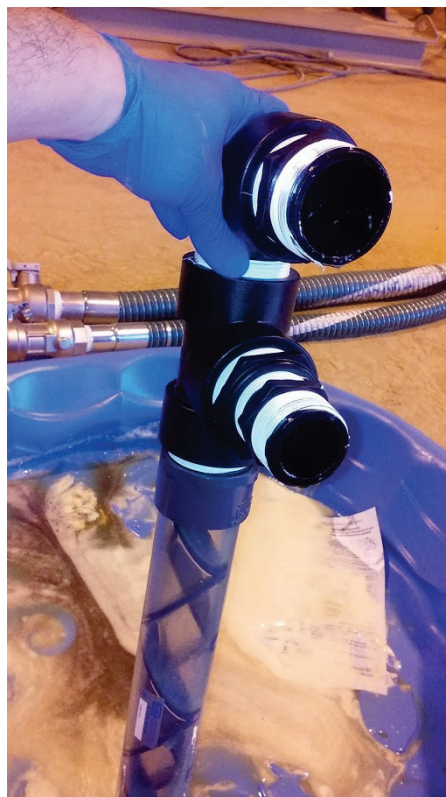
Figure 3.3. CRADR1 mixing nozzle  
following initial operation  
4 August 2016.

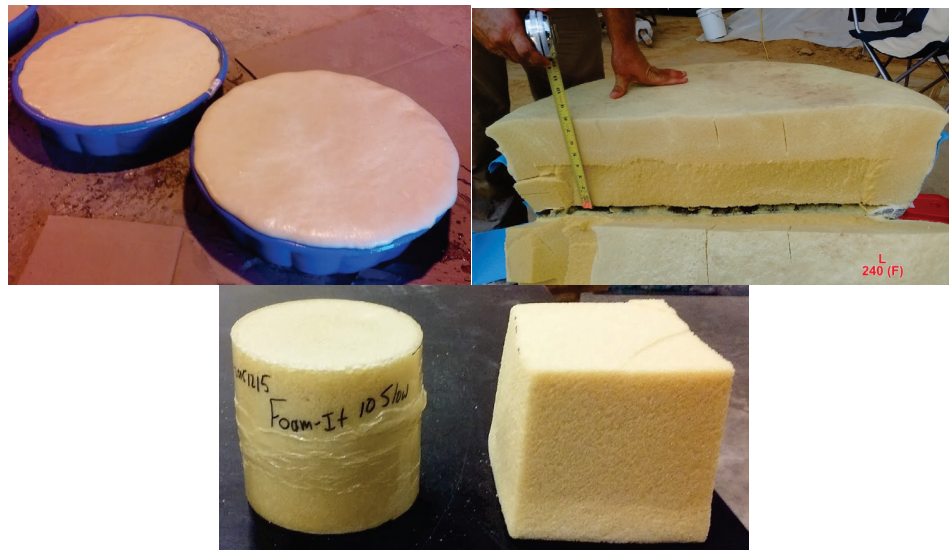
Figure 3.4. Foam samples in 20-gal trays (top left), depth of foam samples (top right), and comparison of resulting UCS sample (bottom right) to lab sample (bottom left).

Fully formed foam as dispensed is shown in Figure 3.4. The foam cured to the point of supporting weight within 15 min. Following 2 hr of cure time, each container was cut in half to determine the quality of the final foam. The final product was tested following 4 hr of total cure time; per the supplier, this material achieves full cure within this time span. The unconfined compressive strength (UCS) of the two samples produced are shown in Table 3.1. Specimens analyzed from these samples did not follow guidelines specified in ASTM D1621-04a and, instead, were cubic in shape, as shown in Figure 3.4. Additionally, samples were not cut evenly. Therefore, error was introduced to the analysis. UCS at 10% strain was analyzed in addition to the maximum UCS and that at 2% strain. Regardless, UCS at 10% strain and maximum UCS exceeded the threshold specified for both samples.

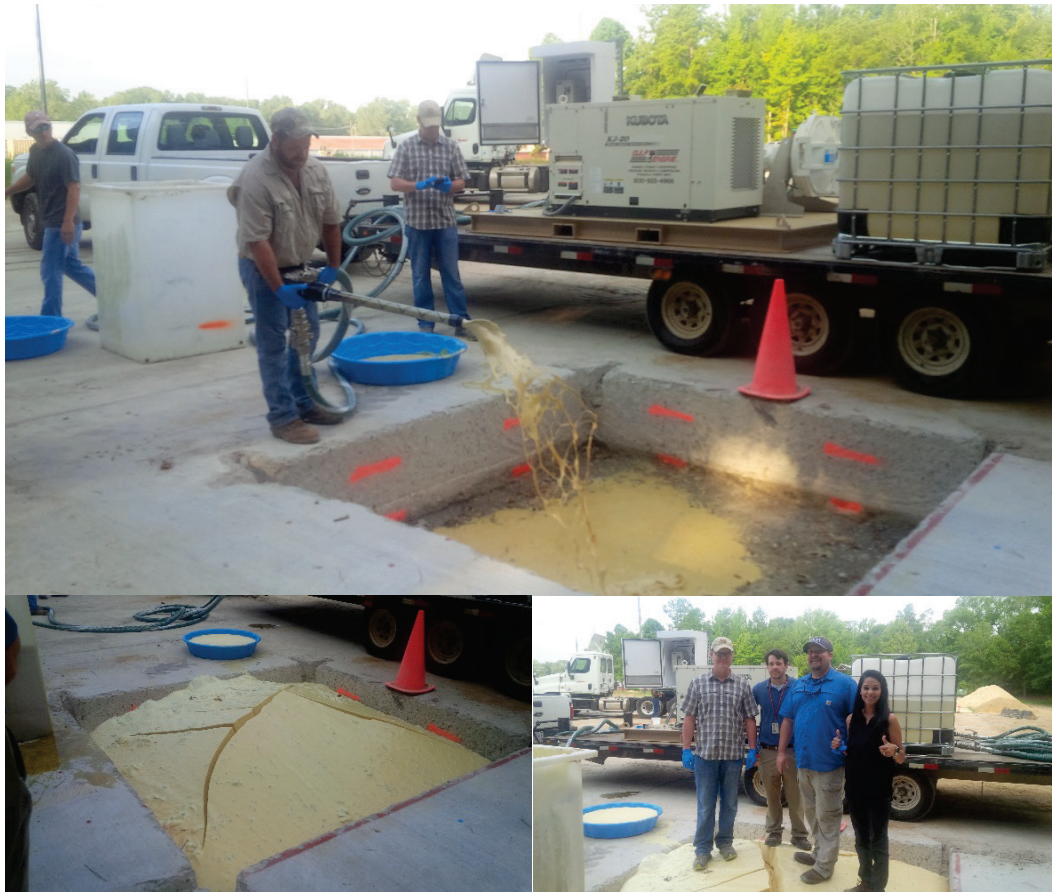
Figure 3.5. Operation of CRADR1 prototype in test crater.

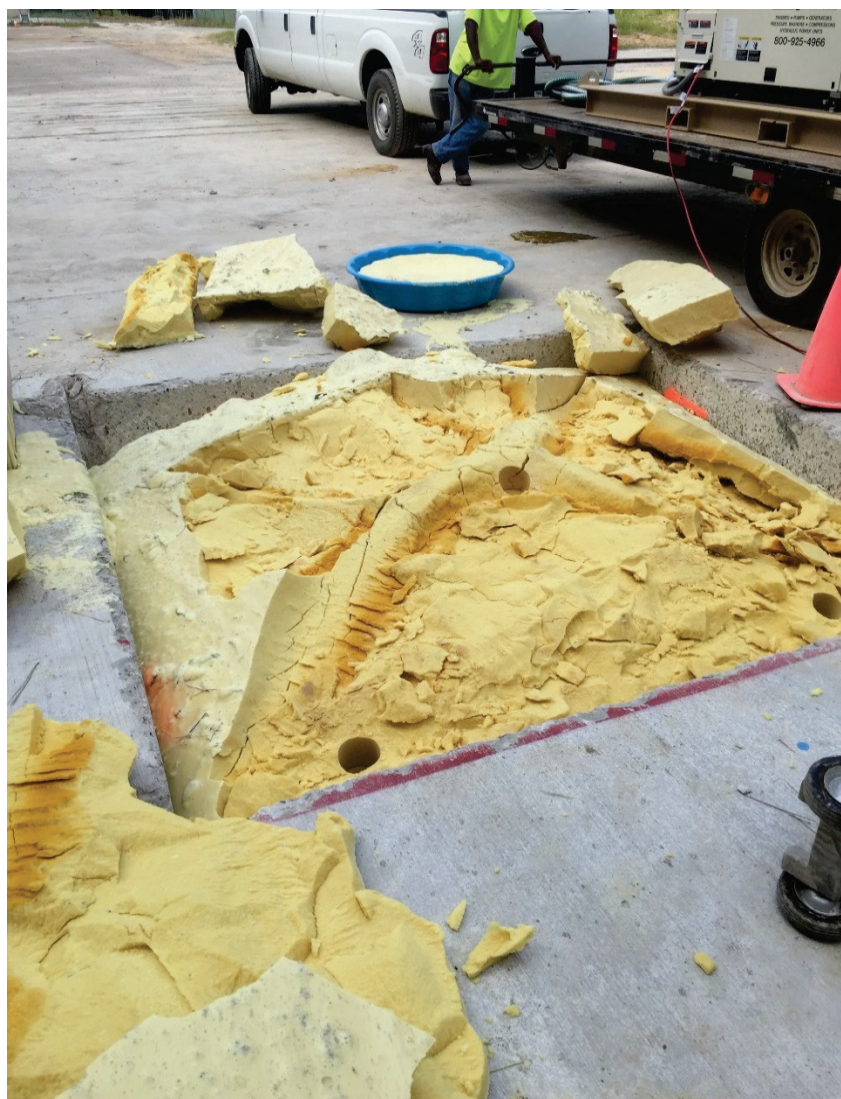
Figure 3.6. Test crater following foam surface removal.

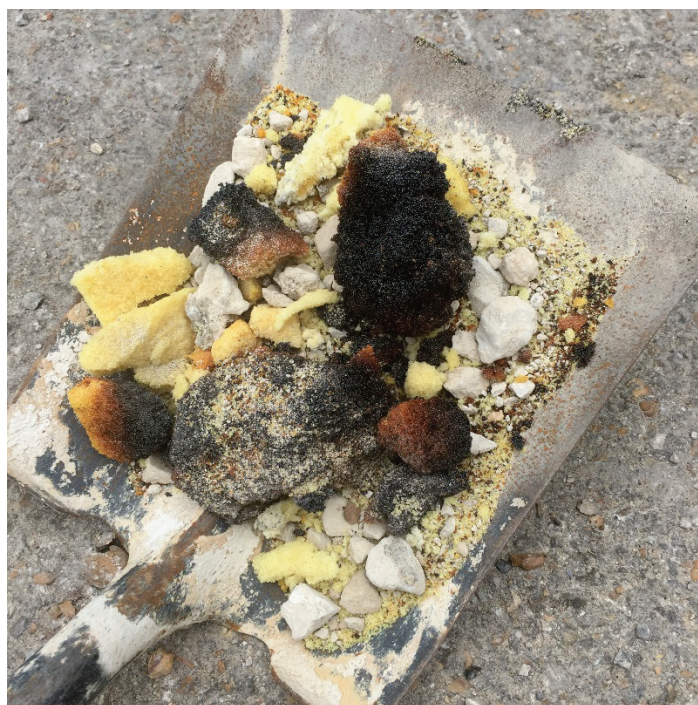
Figure 3.7. Charred foam found at test crater base.

The foam was excavated completely later in the day. Charring, as shown in Figure 3.7, was observed in small areas of the base of the foam. The temperature of the foam base could not be measured during evaluation. Therefore, the maximum temperature of the foam without performance or visual compromise could not be determined.

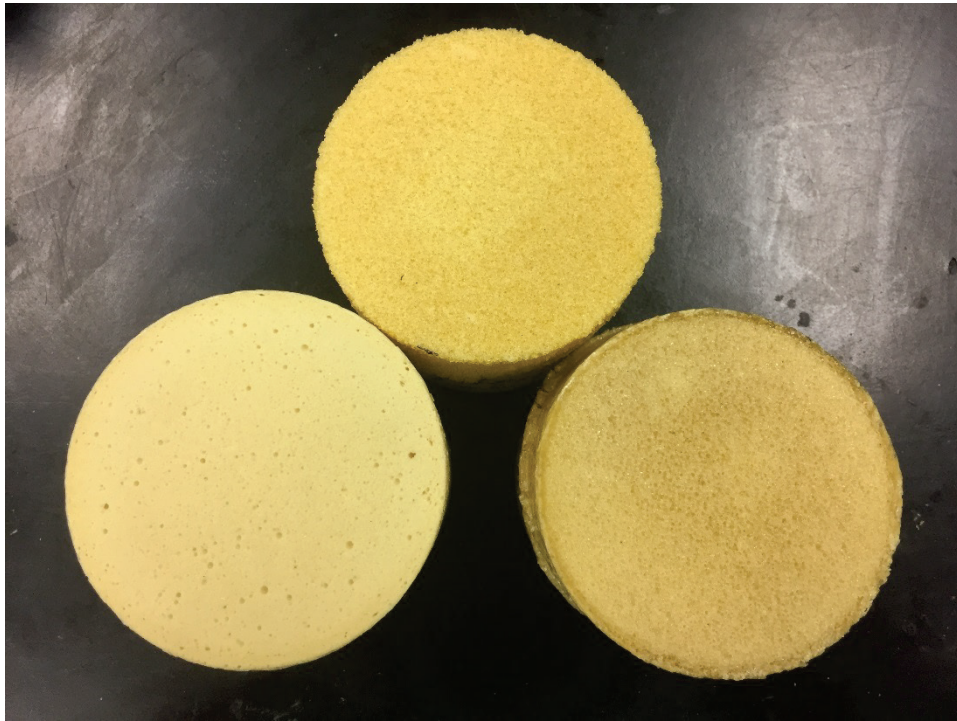
Figure 3.8. Cell structure of sample from field crater (top) and lab samples prepared at high (left) and low (right) mixing rates.

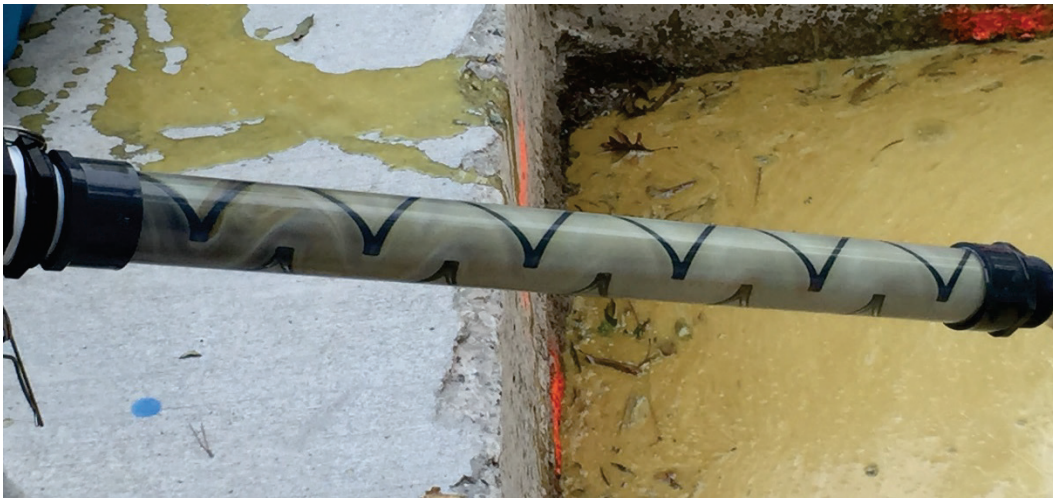
Figure 3.9. Foam mixing within CRADR1 nozzle.

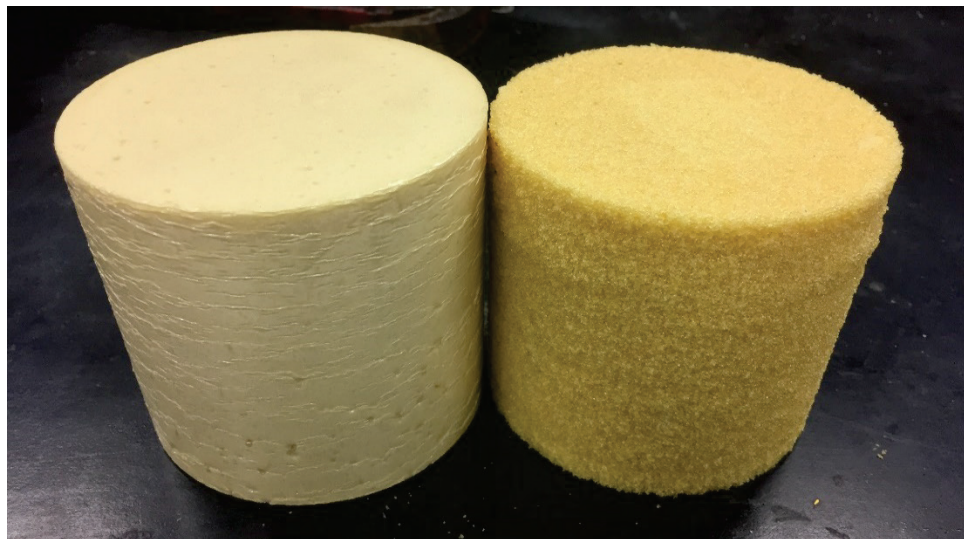
Figure 3.10. Profile view of samples from lab (left) and field (right).

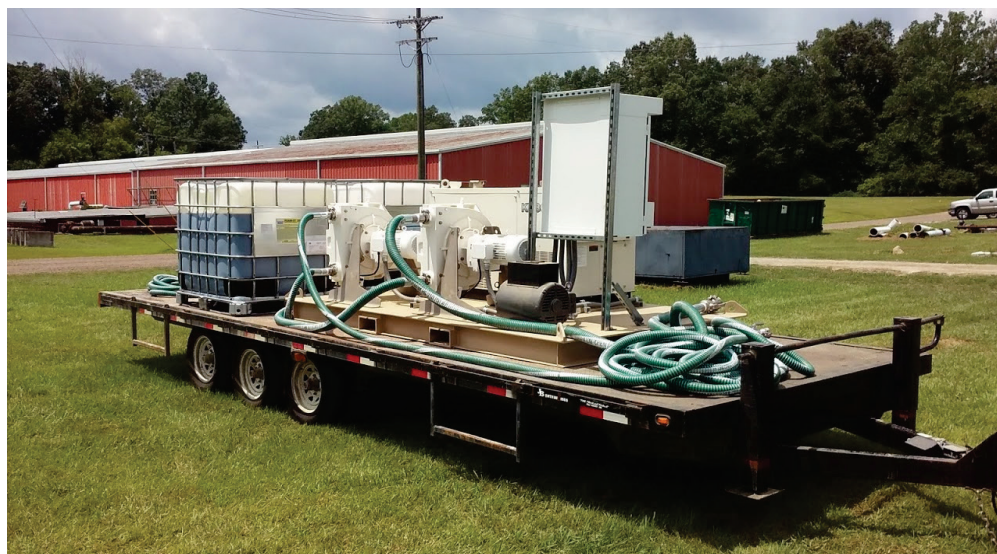
Figure 3.11. Final assembled hose pump foam dispensing prototype.

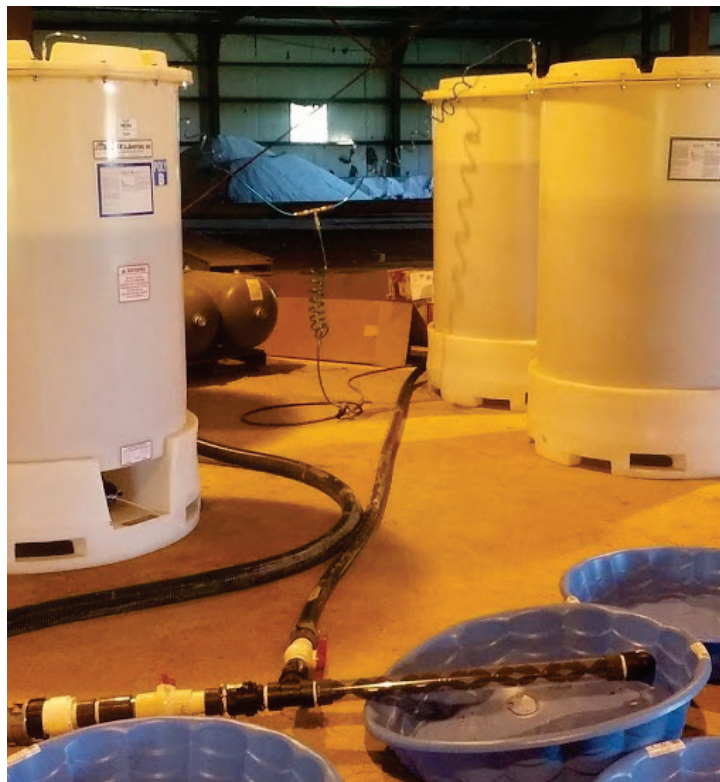
Figure 3.12. Pressure-driven foam dispensing prototype.

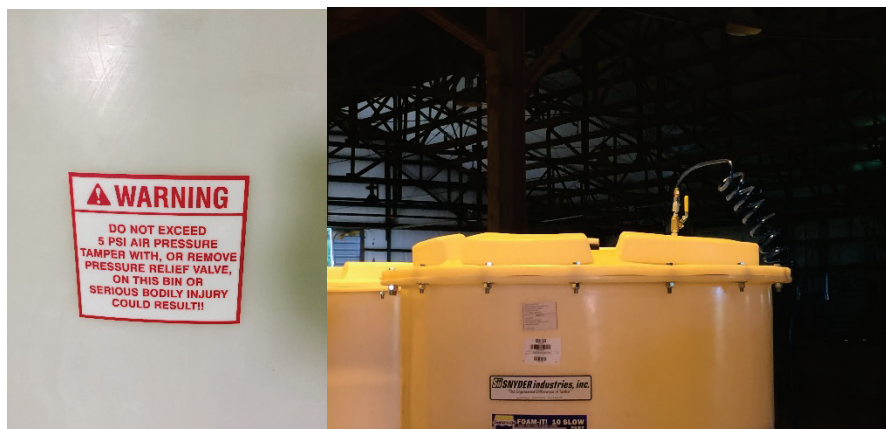
Figure 3.13. Warning label (left) and crowning (right) from 5 psig within Poly Visco tote.

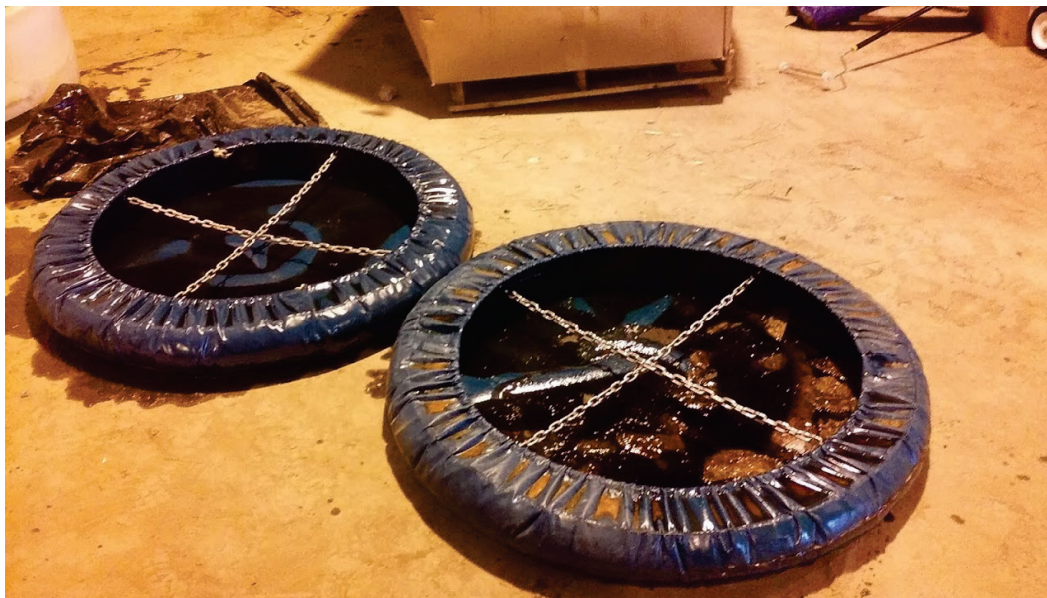
Figure 3.14. Side scraper assemblies as removed from Poly-Visco totes.

Predicted flow rates for component A in an air-driven prototype were consistent, but component B failed to reach the flow rates predicted by the Bernoulli equation. This indicates that either 1) at least one of the required assumptions fails for component B in larger scale testing or 2) an unexpected design failure occurred. Since component B is a polymer solution, the most likely failed assumption would be Newtonian flow. Polymers sometimes exhibit a shear thickening behavior wherein the liquid viscosity of the solutions increases at higher shear rates corresponding to higher flow velocities in pipes. This would increase the energy required to accomplish a given flow rate for component B in any system. Positive displacement pumps can provide the extra power required, but an intentionally low-power system would not be able to compensate. The most likely equipment failure would relate to the viscous material totes. Each of the totes is equipped with a scraper that is meant to sit on top of thick liquids inside the tote and assist in cleaning highly viscous materials from the tote as the liquid level decreases. The possibility of improperly assembled totes was checked by removing the top of the totes to ensure that the side scrapers were present. For the two totes checked, the side scraper assemblies were not on top of the liquid, but rather were found sitting on the bottom of the liquid in the tote. This position would have hindered free draining of the components from the totes, and most likely contributed to the slow flow rates observed during testing. The side scraper assemblies

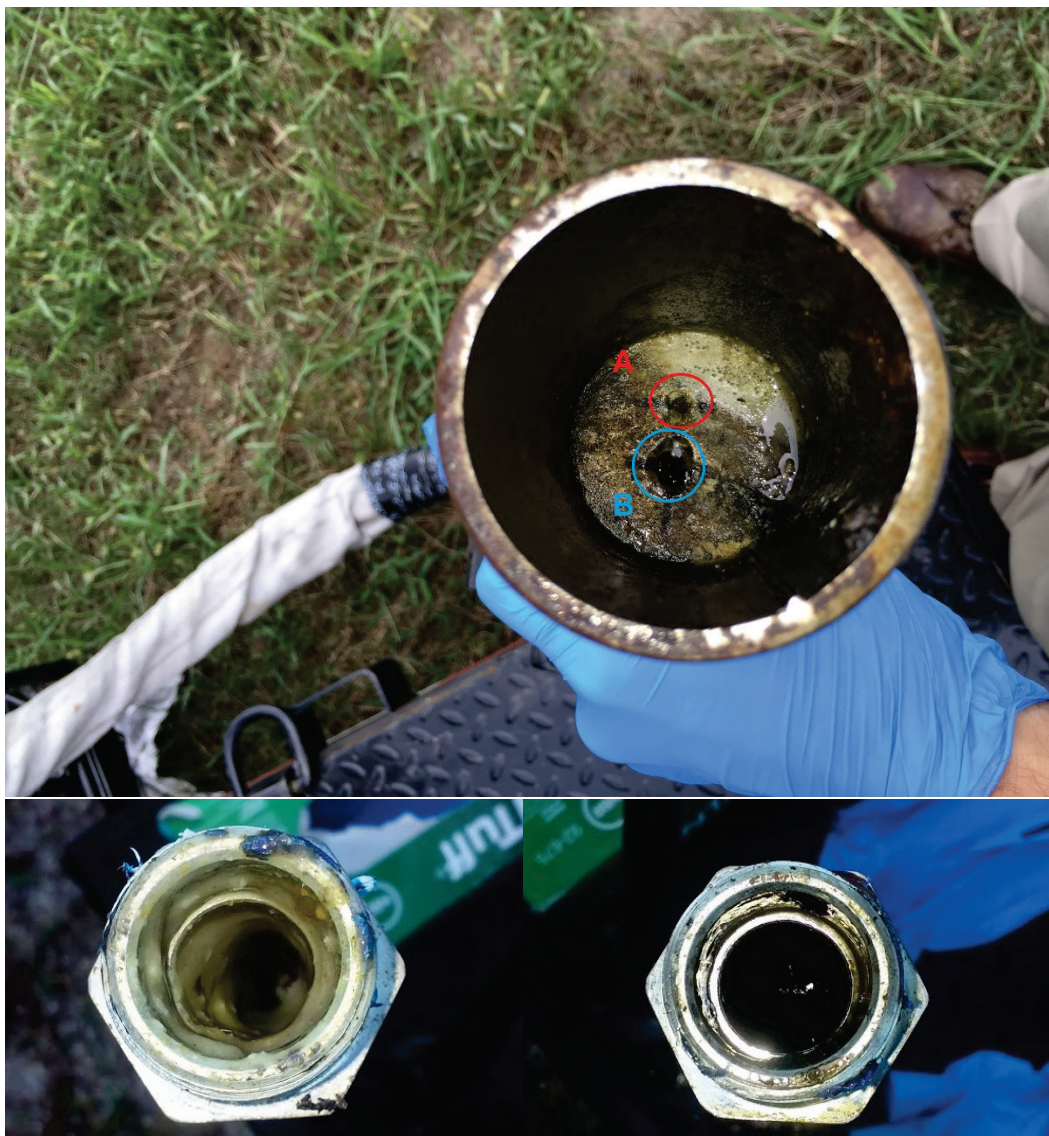
Figure 3.15. HMI prototype mixing nozzle outlet head (upper), Component A connection (lower left), and Component B connection (lower right).

Technicians from HMI traveled to Vicksburg to troubleshoot the system. The steel nozzle was completely clogged with polymerized product and required mechanical foam removal with steel drill bits. Once the nozzle was drilled through, a solvent flush with brake pad cleaning sprays helped to clean the nozzle. The ball valves were also removed from the end of the hoses to check for clogging. A significant amount of material was polymerized in the component B hose. As the technicians began removing this material, pressure from the hose released and sprayed component. Both ball valves were replaced, and a quick function check ensured that both pumps were moving material.

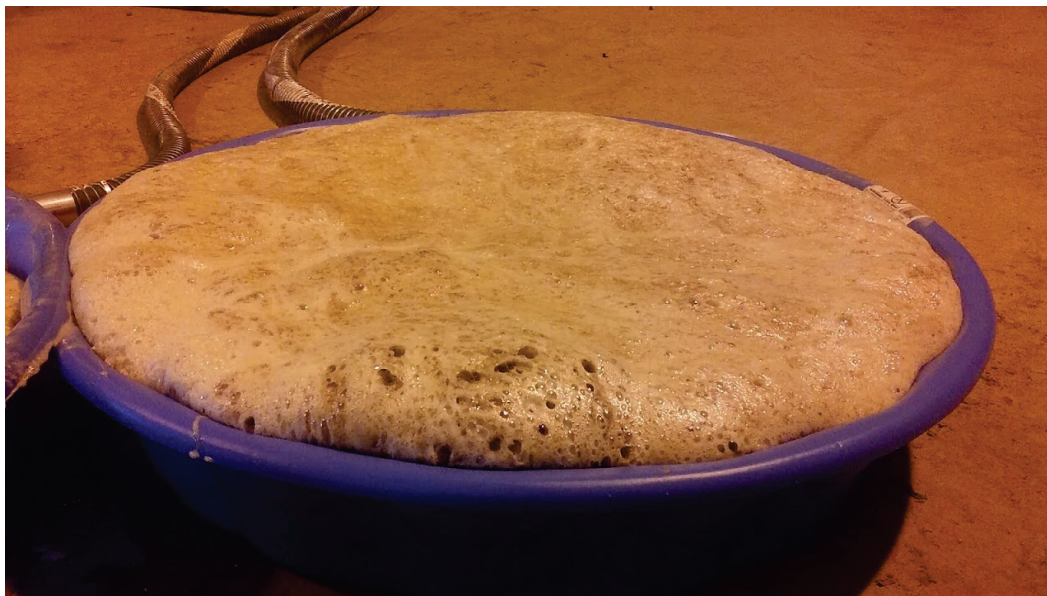
Figure 4.1. Polyurethane foam applied to wet soil in a plastic container.

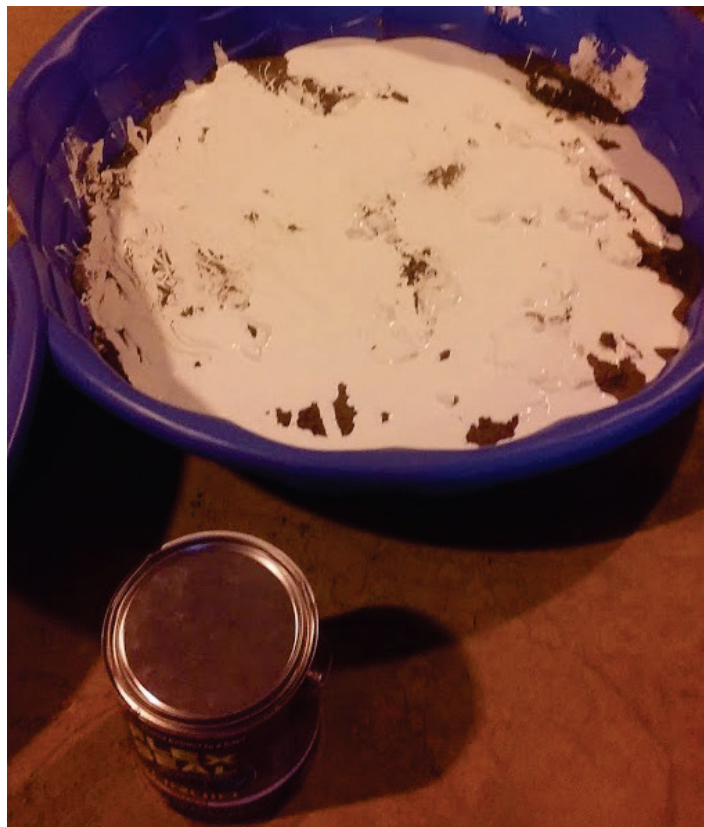
Figure 4.2. Flex Seal® applied to wet soil.

Flex Seal as applied did not prevent water from adversely impacting foam performance over wet soil. This may be due to the hydrophobic barrier allowing water to escape upwards and pool on top of the barrier before foam application. It is also possible that a 2-hr cure time is insufficient for this material; a full 24-hr cure time is recommended by the manufacturer. In either case, the material is not capable of meeting threshold requirements for a basic moisture barrier in a crater, and Flex Seal is not recommended for this particular application.

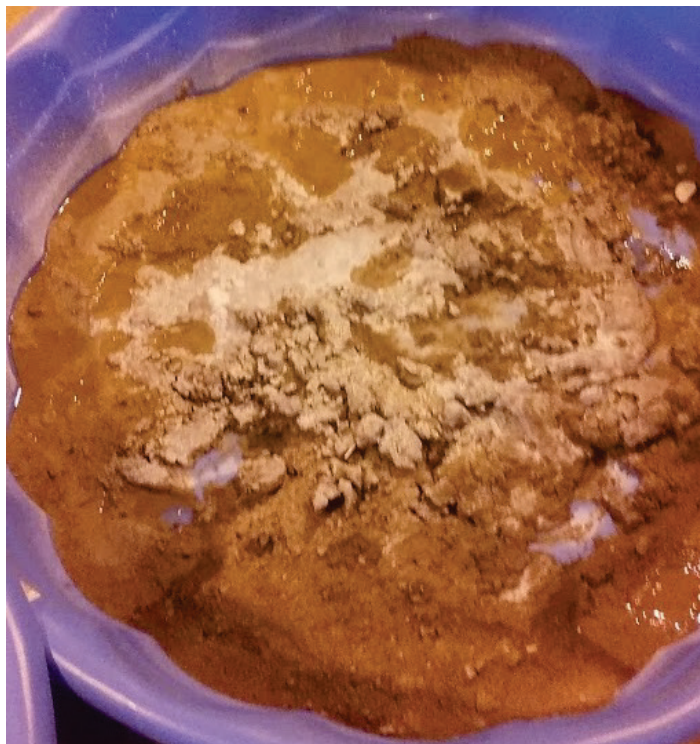
Figure 4.3. NeverWet® applied to wet soil.

The sealant was allowed to cure for 2 hr before applying foam directly on top of the barrier. FOAM-iT!® 10 SLOW was placed using the CRADR1 prototype, and the material was allowed to fully cure. After 2 hr, the foam was visibly less dense than similar examples of the same foam product applied in dry containers. The foam was also visibly more flexible when pressed by hand. There was no apparent improvement in foam performance when compared to the control soil.

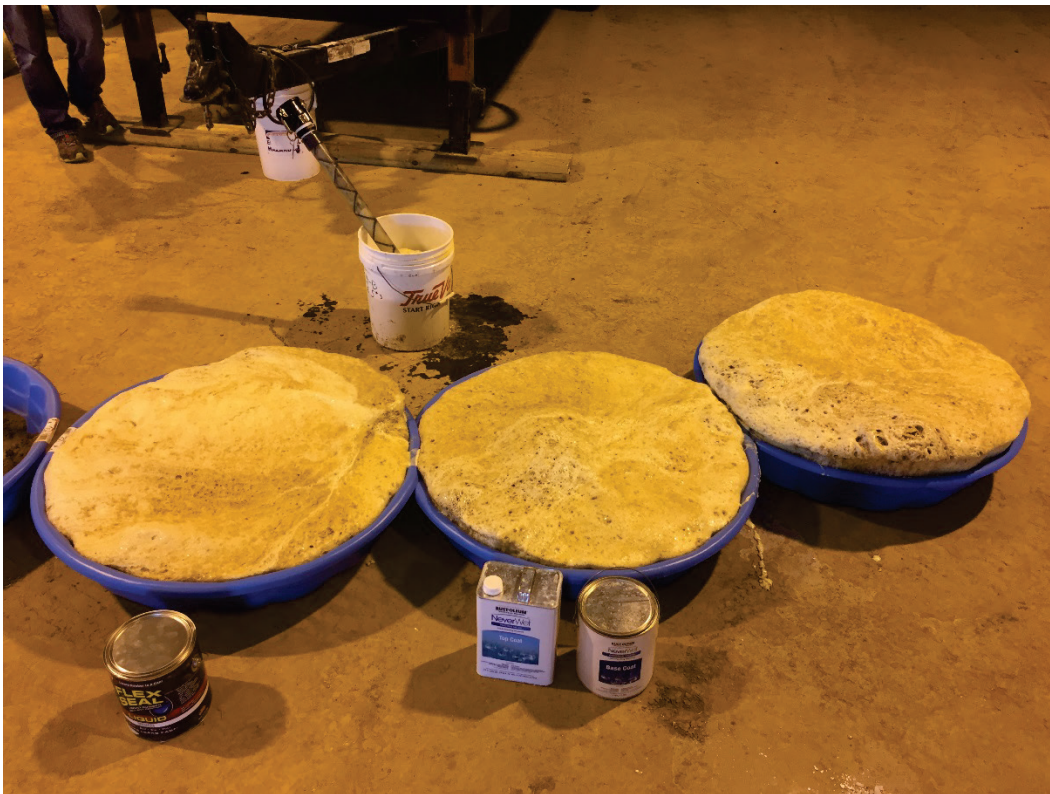
Figure 4.4. Cured moisture barrier samples using wet soil. Flex Seal (left), NeverWet® (center), and control group with no barrier (right).

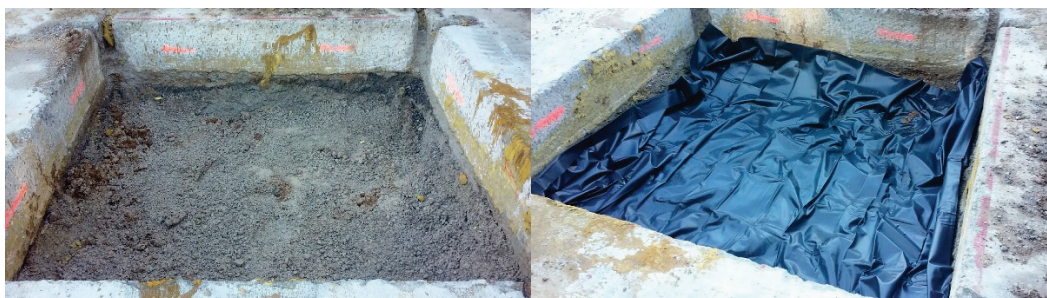
Figure 4.5. Test crater before (left) and after (right) adding a PVC liner.

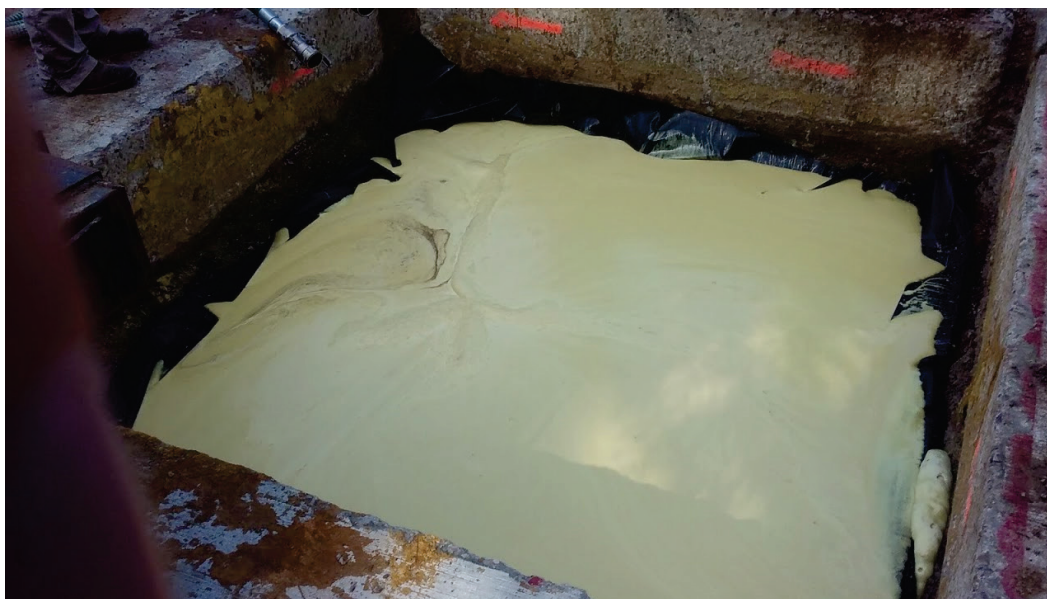
Figure 4.6. Test crater with wet soil lined with PVC directly after foam placement.

Figure 4.6 shows the foam immediately following placement into the crater. In one location on the perimeter of the crater, the PVC liner sagged allowing for foam to contact the wet soil. At this point a small amount of material reacted to form a visibly less dense foam (lower right corner in Figure 4.6), but this reaction zone was limited to a small area of the total crater. Within the rest of the crater, the foam material expanded and cured as normal. Following placement of the foam material, initial curing occurred within 20 min.

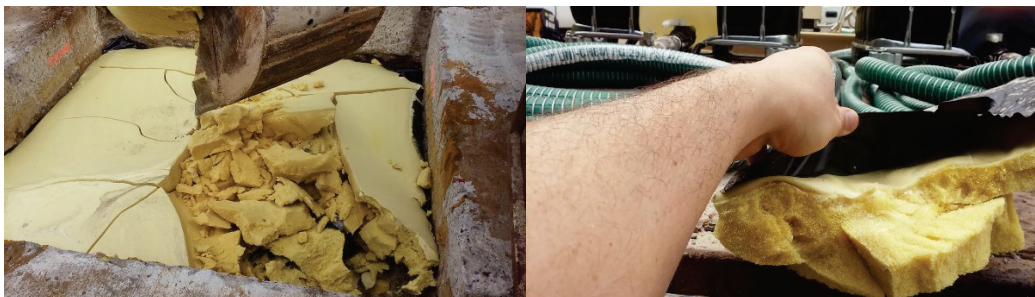
Figure 4.7. Excavating foam out of the test crater to assess PVC liner conditions.

Since the foam curing reaction generates significant heat, the crater was excavated to look for signs of liner failure underneath the center of the crater. Specifically, the liner was evaluated to ensure that it did not melt or form holes that could lead to water intrusion and weak foam or cavity formation during the repair. Photos of the excavation are included in Figure 4.7. No apparent cavities or holes were observed in the liner during excavation of the repair. The weight of the foam material pressed down on the liner while the temperature of the reaction softened the liner slightly. The result was not a hole in the liner, but rather the liner was pressed into small cavities on the crater subgrade resulting in a better overall contact between the foam backfill and the crater subgrade.

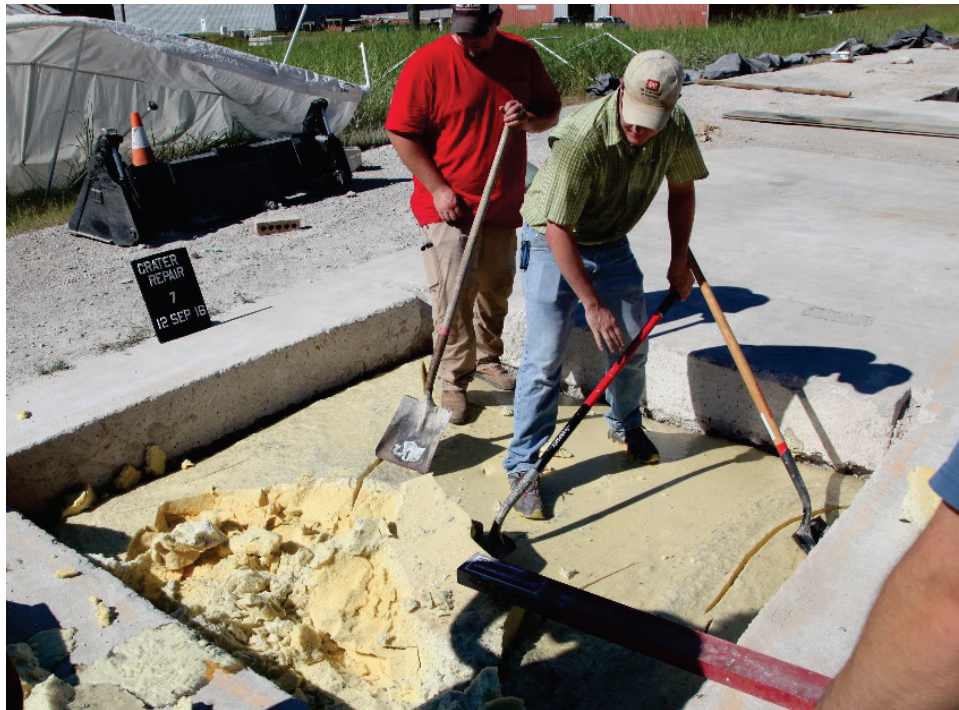
Figure 4.8. Removing excess foam with hand tools.

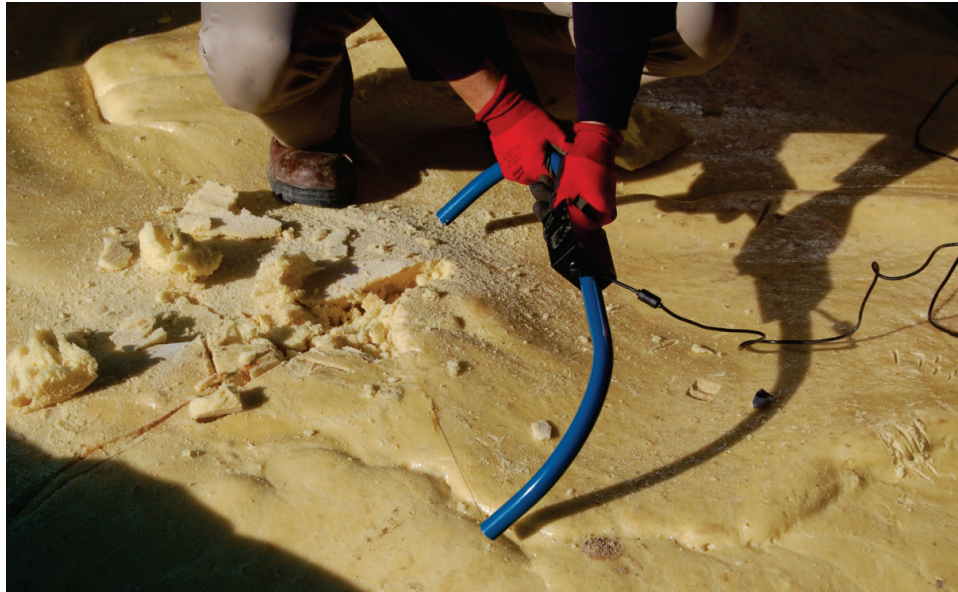
Figure 4.9. Hot-wire cutter.

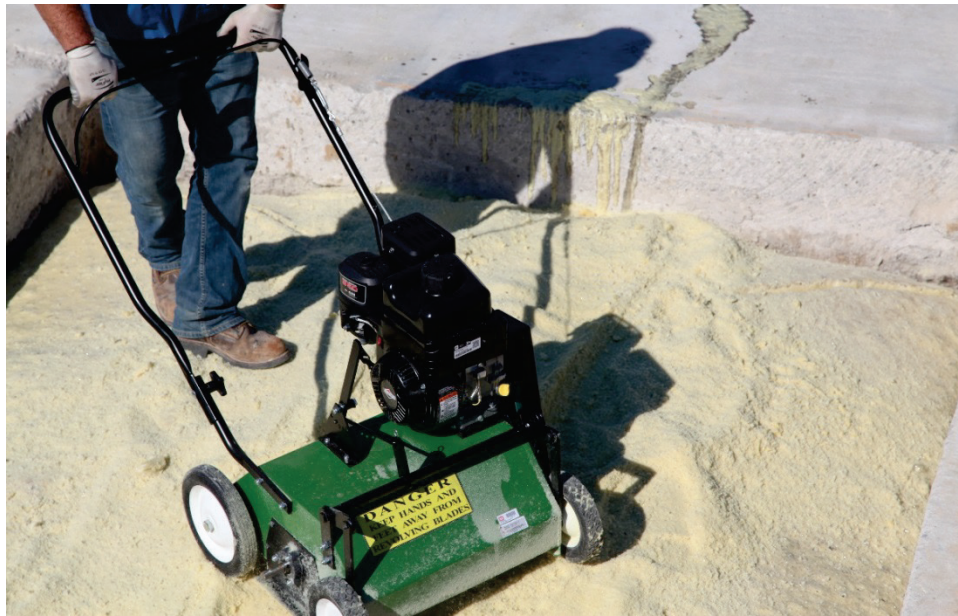
Figure 4.10. Mechanical scarfer.

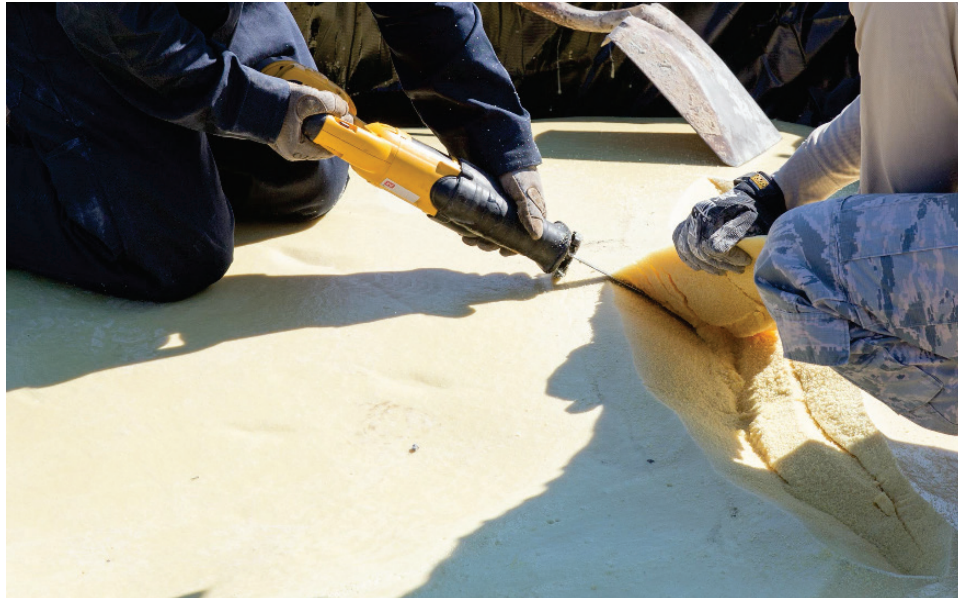
Figure 4.11. Standard saw with construction/demolition blade.

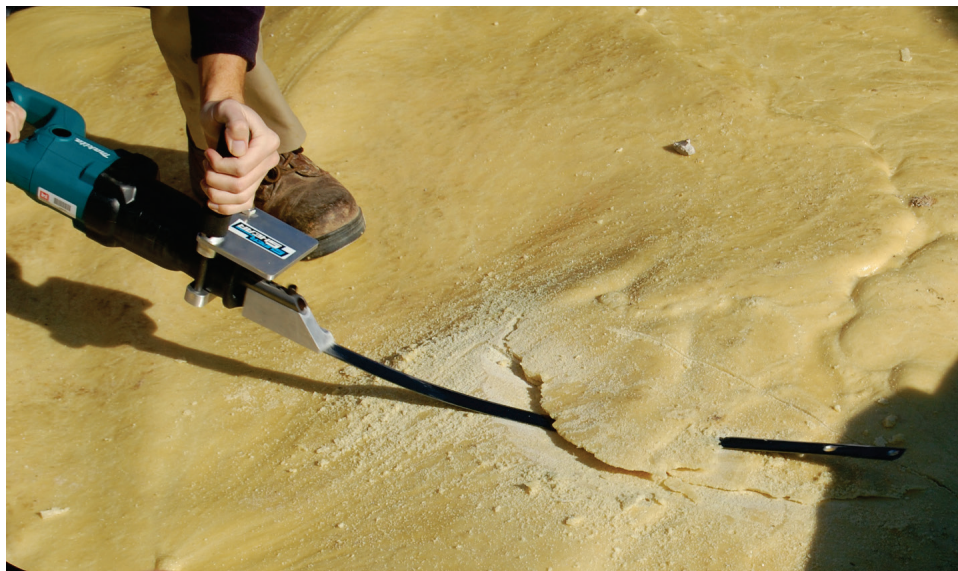
Figure 4.12. Modified saw with a specialized foam cutting blade attachment
